| TECHNICAL BULLETIN | |
| | <b>August 1995</b><br><b>TB 1240</b> |

Resurfacing Cylinder Heads On  
GM 4.3 5.0 & 5.7L Small Block Chevrolet Engines

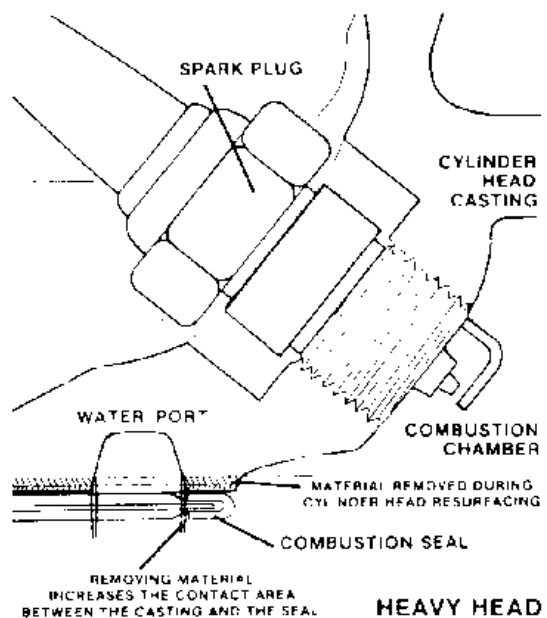
Bulletin Diagram: Untitled Graphic #2081 for TB 01240

Gasket manufacturing engineers state that the walls of the cooling port angle towards one another in pre-1977 heads (see Fig. 1). This different angle increases the sealing area between the combustion chamber and the spark plug cooling port whenever any machining takes place.

It is recommended that AERA members do not remove more stock than is absolutely necessary when working on the newer design head and that a composition type gasket be used in place of a steel shim gasket. A composition gasket offers more sealing area than the protrusion bead on a steel shim gasket, therefore reducing possible leakage.

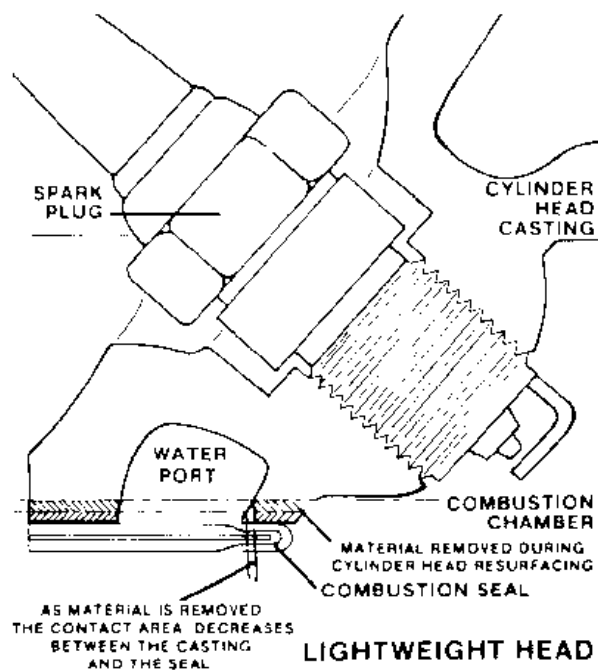
Bulletin Diagram: Untitled Graphic #2082 for TB 01240

Figure 2 shows the difference between the newer and older design. The cooling port walls angle towards the combustion chamber on the newer design. Machining the surface of this head reduces the sealing area between the port and the combustion chamber, which can lead to leakage.
