| <b>TECHNICAL BULLETINS</b> | <b>Make</b> JEEP |
| | <b>Model</b> WRANGLER |

**TB # 1487 REAR MAIN SEAL FAILURE ON 1991-96 CHRYSLER/JEEP 2.5 & 4.0L**

**Rear Main Oil Seal Failures On  
 1991-96 Chrysler/Jeep 2.5 & 4.0L Engines**

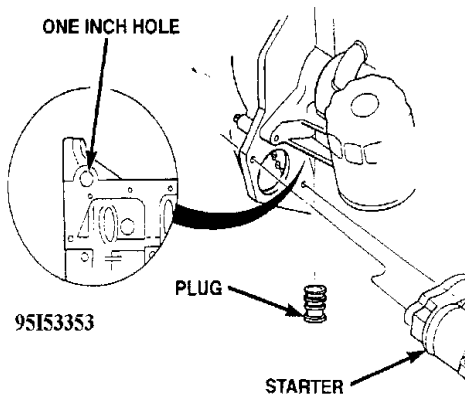
**UNTITLED GRAPHIC #2263 FOR  
 TB 01487**

Engines built from 1991 through 1/1/96 did not incorporate a rubber sealing plug in the rear of the block. This plug, Part #53020465, seals a one inch hole directly above the engines starter. If this plug is missing, dirt or other contaminants may enter the rear bell housing area. The dirt will then surround the crankshaft seal and work its way between the sealing lip and crankshaft. As the crankshaft rotates this contamination becomes abrasive and wears the seal and crankshaft surface.

Installing this plug in engines that operate in dusty/dirty conditions will significantly extend rear seal durability. Jeep began installing this plug on 1/1/96 in all 2.5 & 4.0L engines.
