| TECHNICAL BULLETIN | |
| | <b>May 1998</b><br><b>TB 1576</b> |

Ticking Noise On  
1993-96 Chrysler 3.5L VIN F & G Engines

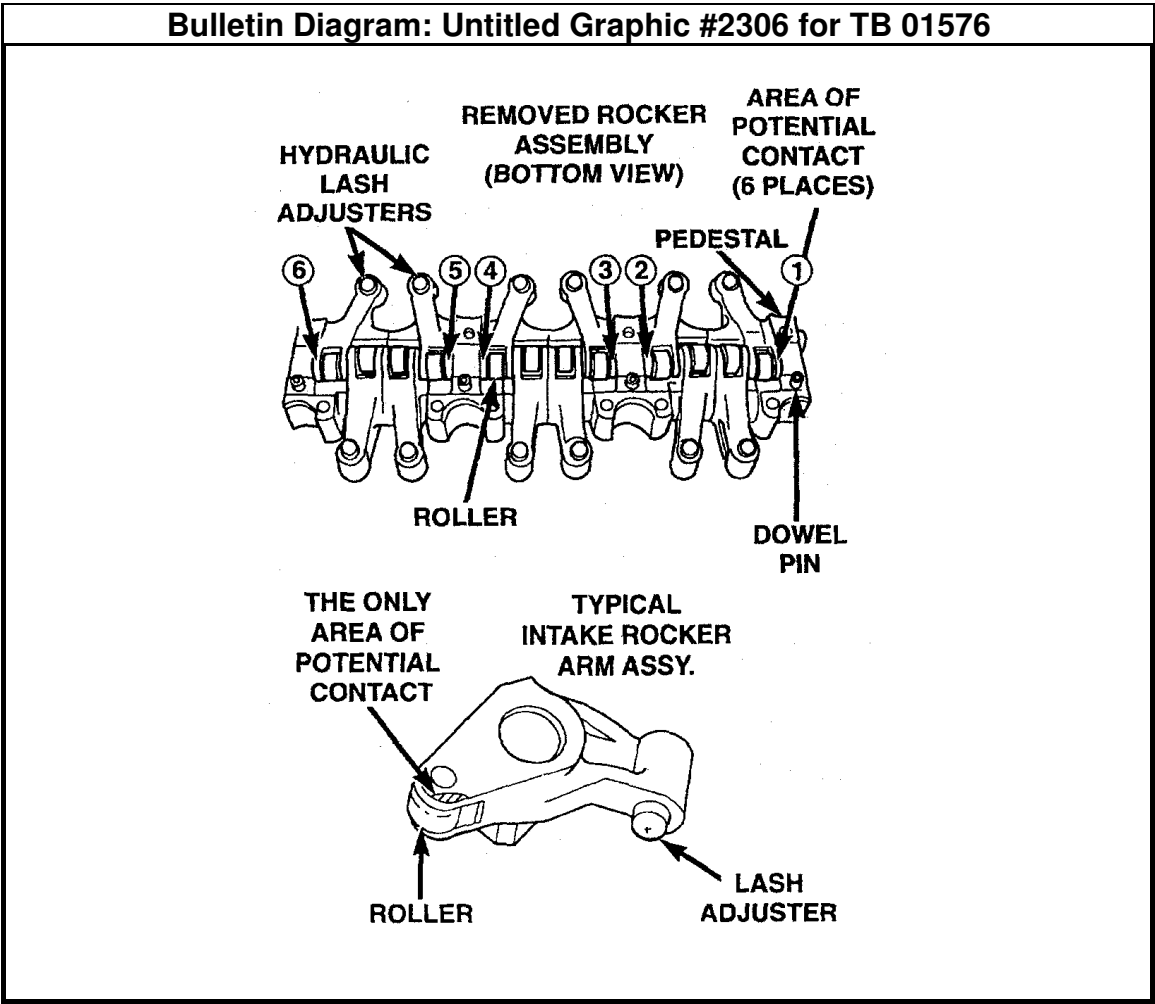
Upon removal of the valve cover and rocker arm assembly, inspect the bottom side of the rocker arms for contact with the camshaft. Worn rocker arms will appear as freshly shaved, bright aluminum instead of the original oil-stained, dull looking rocker arm. Contact can be present on more than one rocker arm on either bank. If signs of contact are evident, replacement of the damaged rockers and the camshaft is needed.

If there are no signs of contact, check the lash adjusters for being soft or spongy.

Rocker arms with soft or spongy lash adjusters should be replaced. The table above lists the components and part numbers required to perform this replacement procedure.
