| TECHNICAL BULLETIN | |
| | <b>TB 1599</b> |

Premature Main Bearing Failures On  
1996-2003 GM 4.3L VIN W & X Engines

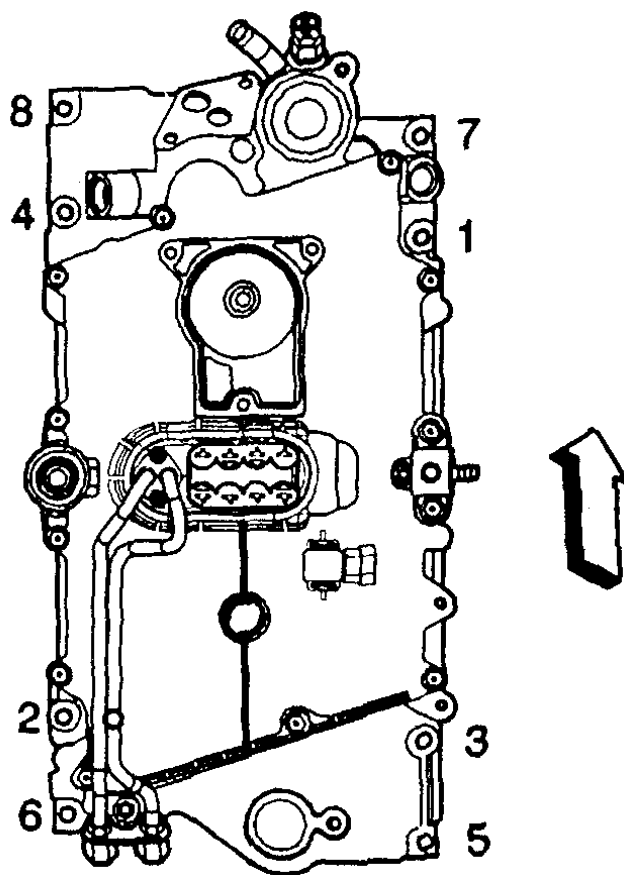
Bulletin Diagram: Untitled Graphic #2325 for TB 01599

Beginning in 1996 General Motors revised the method of mounting this manifold to the cylinder heads. This revision was made so that the intake manifold bolts go into the cylinder head in a vertical position. Over tightening of the intake manifold bolts may cause the crankshaft main bearing bores to become distorted, reducing oil clearance to the bearings. To reduce main bearing failures, follow the correct torque procedure and sequence listed below.

**Lower Manifold Torque**

Step 1. 27 In/Lbs  
Step 2. 106 In/Lbs  
Step 3. 11 Ft/Lbs

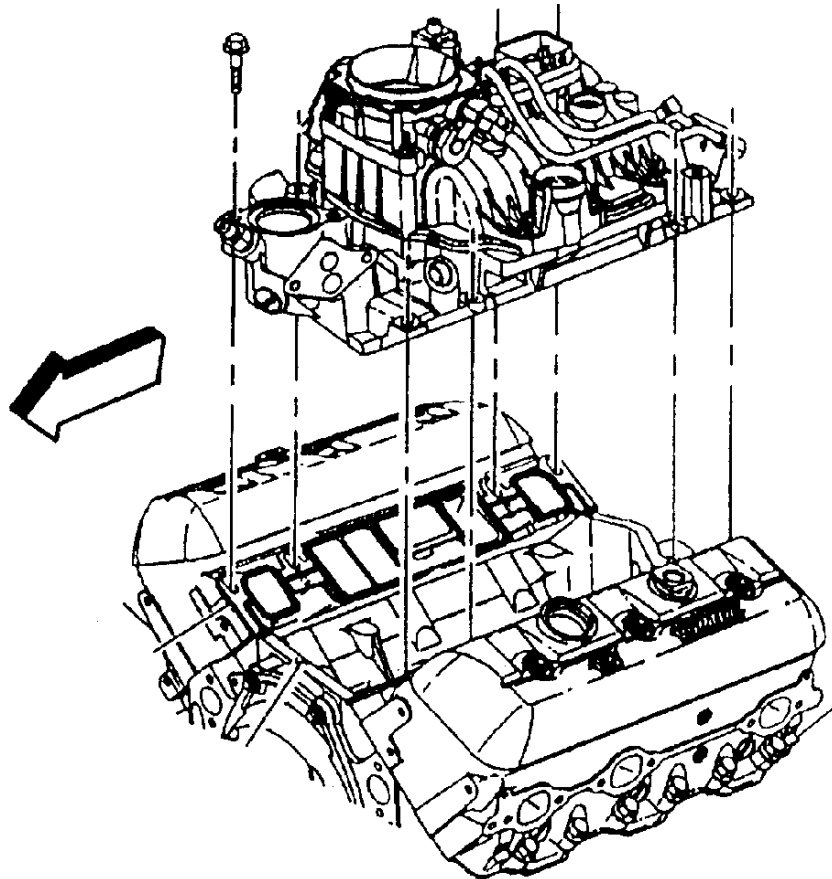
Bulletin Diagram: Untitled Graphic #2326 for TB 01599

\*NOTICE: General Motors states; If intake manifold bolt torque and tightening sequence is not followed as shown in this Technical Bulletin, the main bearing bore may become distorted, which may cause main bearing failure.

**Upper Manifold Torque**

44 In/Lbs  
88 In/Lbs  
-----
