| TECHNICAL BULLETIN | |
| | <b>September 1998</b><br><b>TB 1613</b> |

Cylinder Head Caution On  
1989-96 GM 4.3L VIN W & Z Engines

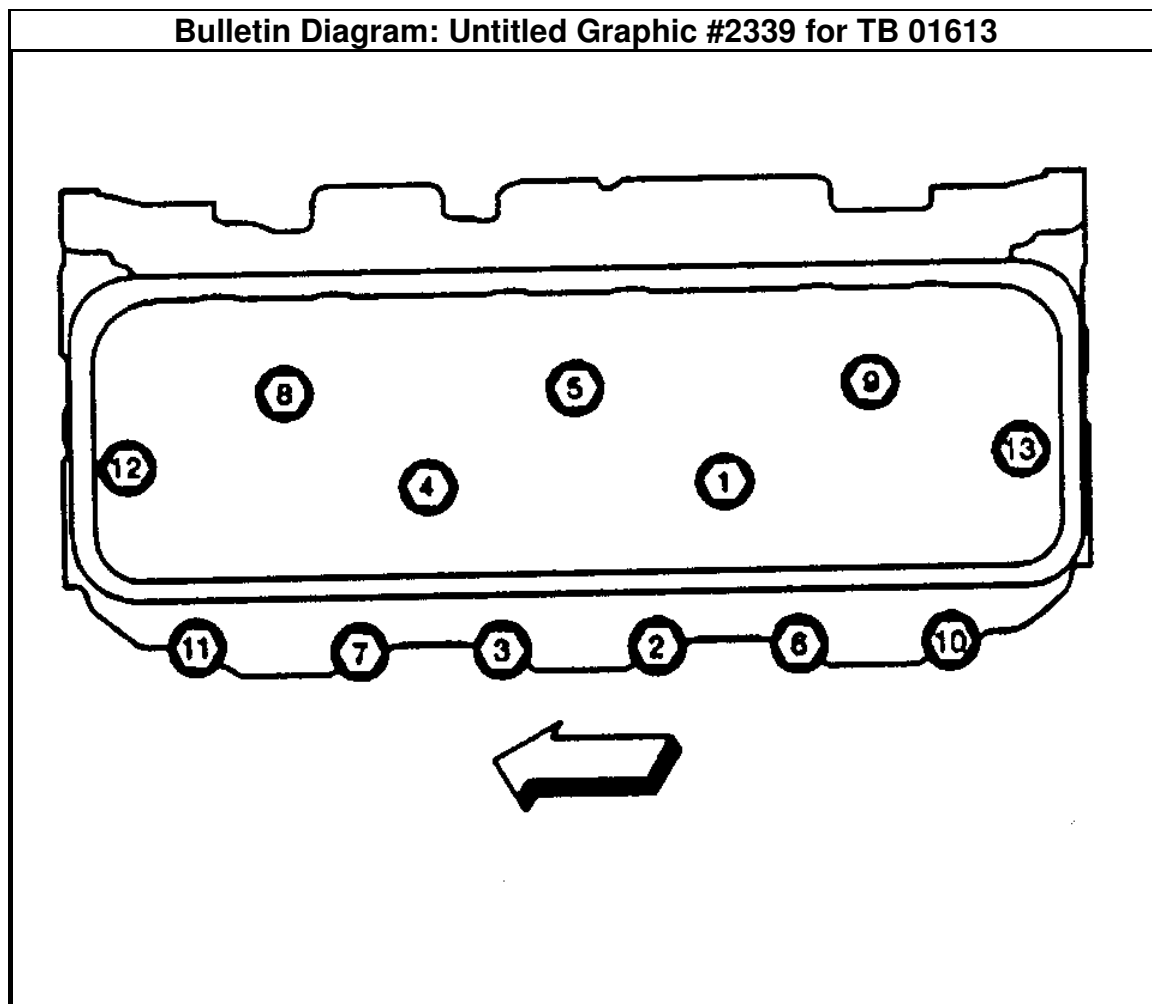
**Bulletin Diagram: Untitled Graphic #2339 for TB 01613**

AERA members have reported coolant loss shortly after supplying rebuilt cylinder heads or complete engine assemblies. Leaks have been reported on assemblies that had previously been pressure checked and were not leaking at the time of assembly. The source of this coolant loss has been through the cylinder head casting in a crack that developed after installation. This crack has been observed on both banks starting at a head bolt boss continuing over toward a spark plug hole machined taper. There have been no reports of this crack extending into the spark plug threads.

Not all cracks reported have been visible to the eye, even when magnetic crack detection equipment has been used. In some instances, the cylinder head mounting bolt torque was simulated to achieve coolant leakage during pressure testing. Some AERA shops have indicated the use of "wet" crack detection equipment has revealed a crack, whereas, the dry method would not show one in that location.

The cause of these cracks may be different stresses created by re-assembling the head to the cylinder block, as many heads did not exhibit a leak prior to installation. To reduce that possibility one AERA shop is using only new head bolts with a pre-applied lubricant/sealer. They're also using the three step torque procedure and sequence listed below.

1. Torque all bolts in sequence to 22 ft/lbs.

2. Torque all bolts in sequence to 44 ft/lbs.
3. Torque all bolts in sequence to 66 ft/lbs.
