| TECHNICAL BULLETIN | |
| | <b>July 1999</b><br><b>TB 1672R</b> |

Revised Head Bolt Torque Procedure On  
1996-03 Ford 3.8L VIN 4 Engines

Mfg: FORD  
Model: WINDSTAR  
Liter: 3.8L  
VIN: 4  
Year: 96-03

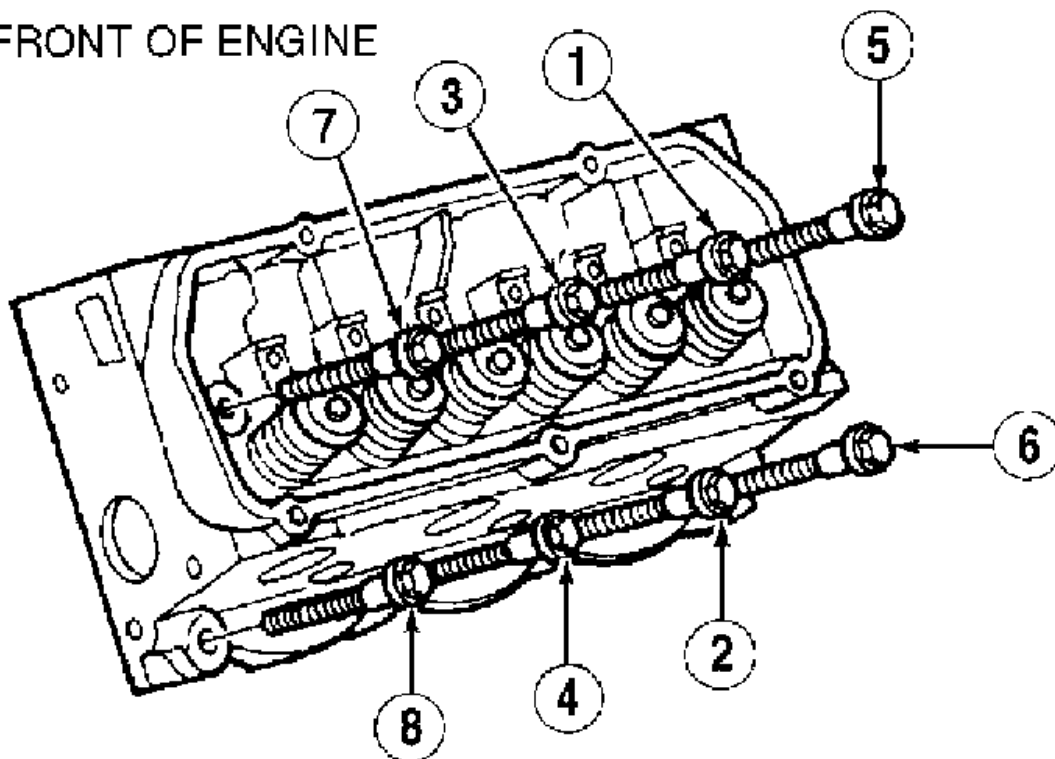
### Bulletin Diagram: Untitled Graphic #2393 for TB 01672R

The AERA Technical Committee offers the following information on revised head bolt torque procedure used on 1996-99 Ford 3.8L VIN 4 engines. Premature failure of the head gasket may occur along with engine coolant leakage if this procedure is not observed. If coolant leakage is not addressed, failure may result when the engine is allowed to continue operating.

**Caution:** Do not loosen all of the bolts at one time. Work on one bolt at a time in the sequence shown in Figure 1. Failure to loosen bolts in proper sequence could cause the cylinder head to warp. **Note:** This procedure can also be used on

To reduce the likelihood of this condition, Ford now offers a revised head bolt torque procedure. Correctly following the steps listed below and observing the sequence shown in Figure 1 will help in preventing head gasket failures.

- Step 1) 15 ft/lbs. (20 Nm)  
Step 2) 30 ft/lbs. (40 Nm)  
Step 3) 37 ft/lbs. (50 Nm)  
Step 4) Long bolts: (One Bolt at a time)  
a) Loosen long bolt and back out 2 to 3 turns.  
b) Retorque long bolt 30-37 ft/lbs (40-50 Nm).  
c) Rotate long bolt an additional 175-185° degrees.  
d) Go to the next bolt in sequence.

- Short bolts: (One Bolt at a time)  
a) Loosen short bolt and back out 2 to 3 turns.  
b) Retorque short bolt 15-22 ft/lbs (20-30 Nm).  
c) Rotate short bolt an additional 175-185° degrees.  
d) Go to the next bolt in sequence.
