| TECHNICAL BULLETIN | |
| | <b>December 1999</b><br><b>TB 1701R</b> |
| Model: | NORTHSTAR |

Cylinder Head Installation For  
1993-99 GM 4.0 & 4.6L VIN C, Y & 9 Engines

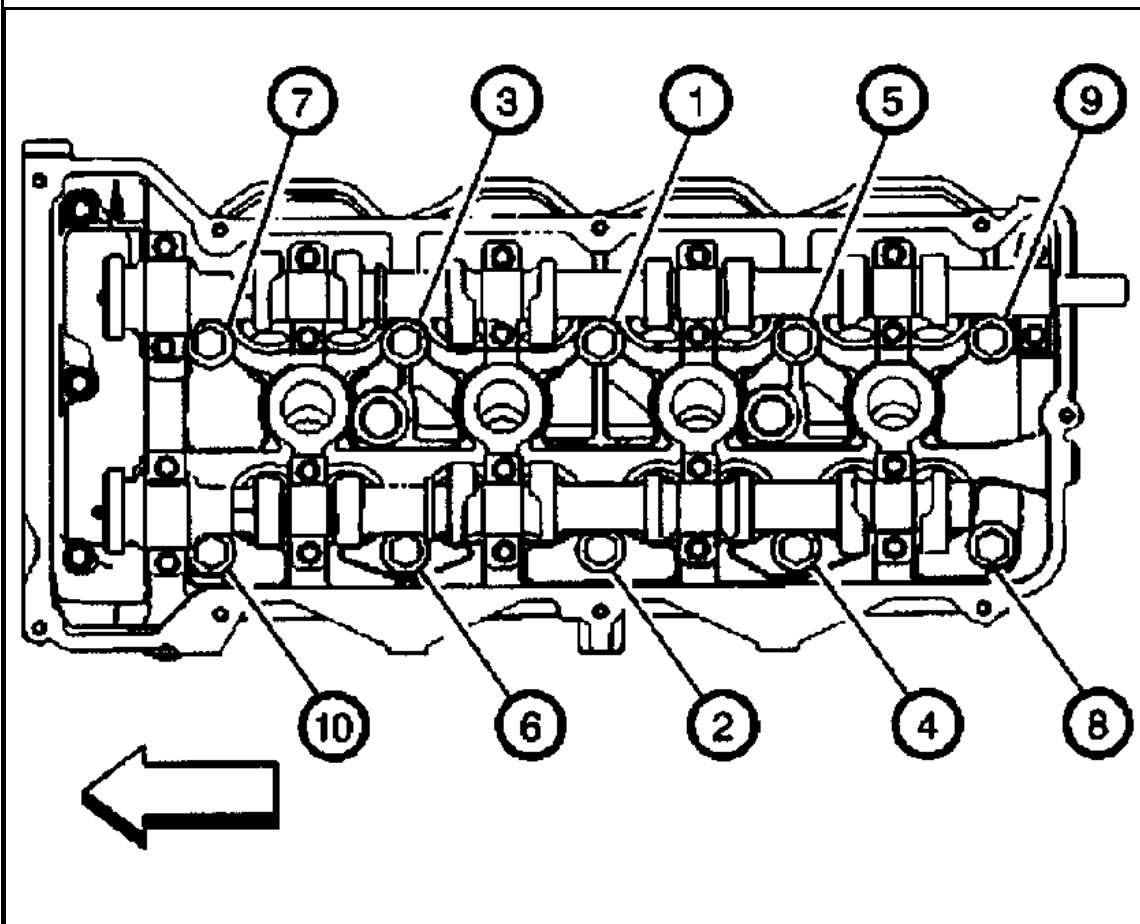
### Bulletin Diagram: Left Side Head Toque Sequence, Figure 1 - CYLINDER HEAD

It is important to note if additional torque is applied during this installation process, the block bolt threads or casting will be damaged. Insufficient applied torque may allow combustion gases to enter the block coolant passages.

1. The cylinder head should be cleaned in solvent and dried. Discard all old 11-mm head bolts and obtain new bolts.
2. The cylinder head and cylinder block mating surfaces should be flat and free of oil residue before the head gasket is placed on the block.
3. In sequence, torque all bolts to 30 ft/lbs.
4. In sequence, rotate all bolts an additional 70°.
5. In sequence, rotate all bolts an additional 60°.
6. In sequence, rotate all bolts an additional 60° (totaling 190° in steps 4, 5 & 6).
7. Torque the front three M6 cylinder head bolts to 106 in/lbs.
