| TECHNICAL BULLETIN | |
| | <b>December 1999</b><br><b>TB 1755</b> |

Piston & Connecting Rod Orientation For  
1982-99 GM 6.2 & 6.5L Diesel Engines

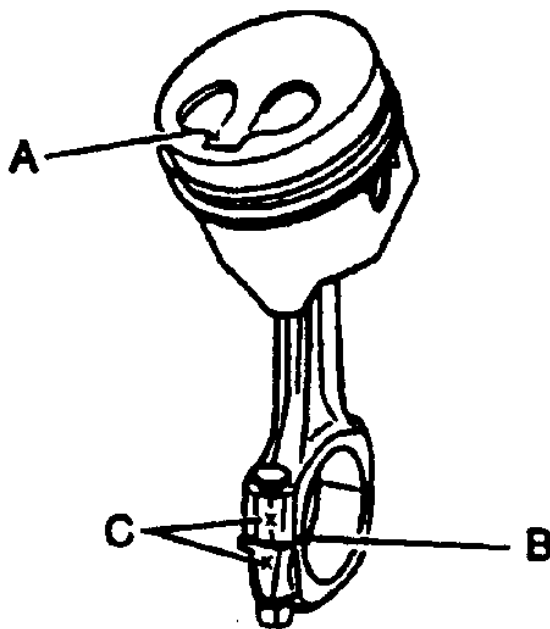
### Bulletin Diagram: TB 1755 Piston To Connecting Rod Orientation

Failure to install the piston assembly into the cylinder bores correctly may lead to drivability complaints and eventual engine damage. AERA members have reported piston scuffing when the pistons have been installed incorrectly.

To mount the piston to the rod, position the piston crown indent on the same side as the connecting rod bearing alignment tangs (See Figure 1 below). When the piston and rod assembly is installed in the block, the combustion area on the face of the piston must face towards the outside of the cylinder or exhaust side of the engine. The connecting rod bearing locating lugs will also be toward the outside of engine when the piston assembly is correctly installed.
