| TECHNICAL BULLETIN | |
| | <b>January 2000</b><br><b>TB 1759</b> |

Camshaft Timing Procedure Caution For  
1993-99 Chrysler 3.2 & 3.5L VIN J, F & G Engines  
(This Bulletin Replaces TB 1063)

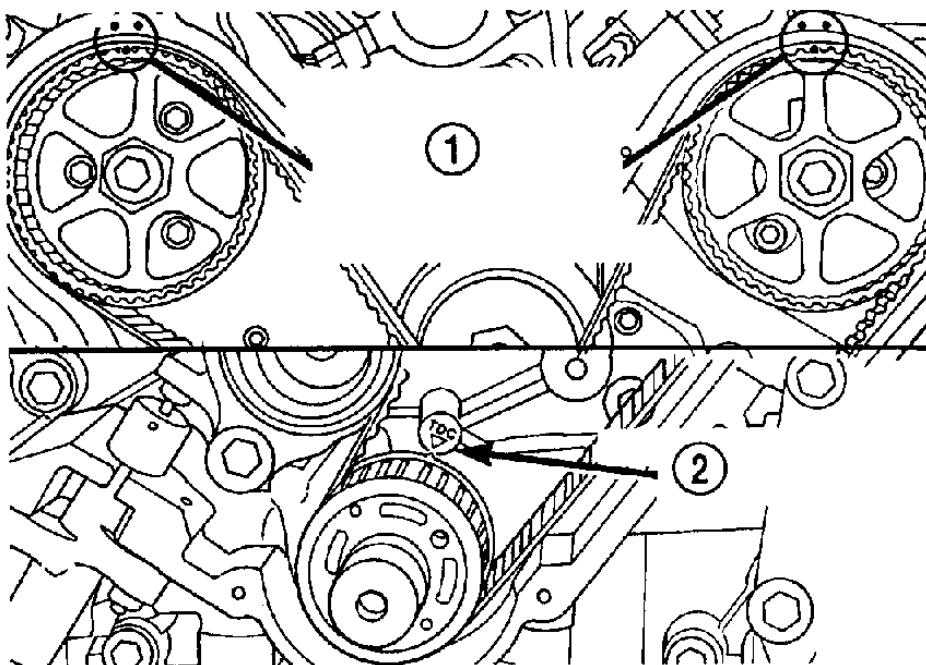
### Bulletin Diagram: FIGURE 1 CRANKSHAFT SPROCKET TIMING MARKS

- 1 – ALIGN CAMSHAFT SPROCKET TIMING MARK BETWEEN MARKS ON REAR TIMING BELT COVER
- 2 – CRANKSHAFT AT TDC

- D) The camshaft sprockets for these engines are not interchangeable. (Figure 3)
  - E) Do not reuse camshaft sprocket bolts.
- 
- 1) Align the timing mark on the crankshaft sprocket with the TDC mark on the oil pump, (Figure 1).

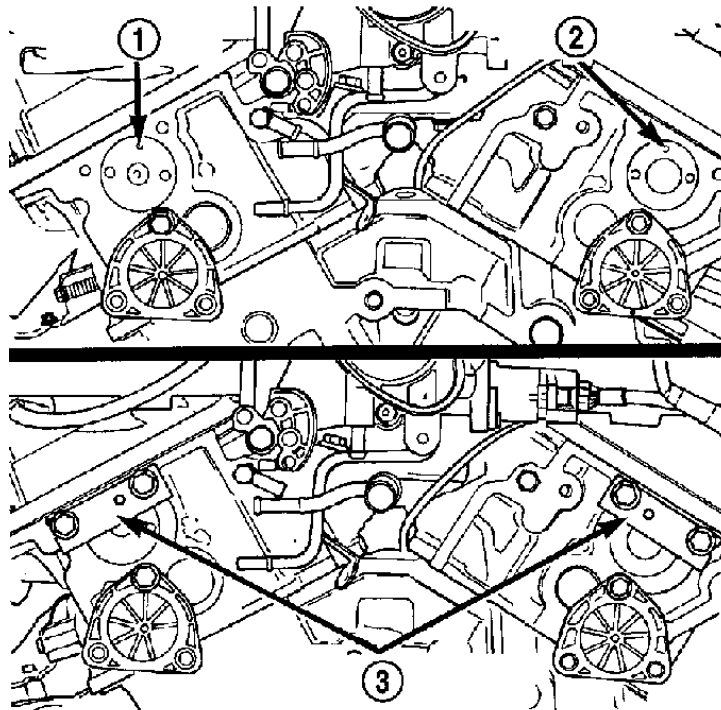
### Bulletin Diagram: CAMSHAFT ALIGNMENT TOOL

- 1 – LEFT CAMSHAFT PILOT HOLE
- 2 – RIGHT CAMSHAFT PILOT HOLE
- 3 – CAMSHAFT ALIGNMENT SPECIAL TOOLS 6642

- 2) Install a dial indicator in number one cylinder and rotate engine to exactly locate TDC.
  - 3) Rotate each cam so the positions of the locating dowel pins are both towards the center of the engine. Install the camshaft alignment Special tools #6642-A as shown in Figure 2 at the rear of each cylinder head. Doing so will lock the camshafts in place.

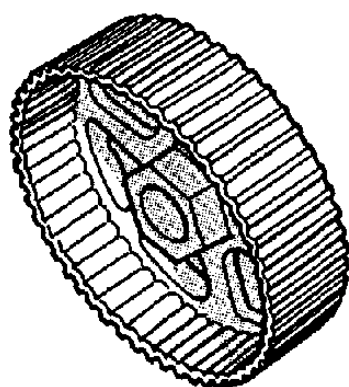
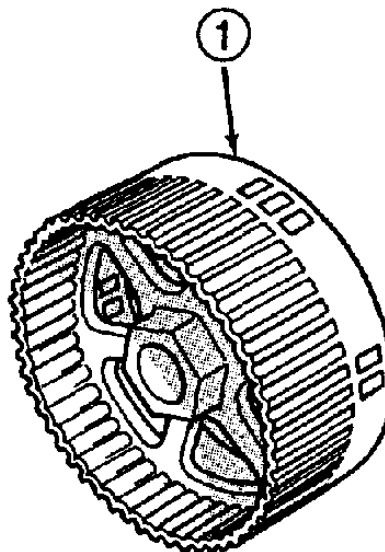
### Bulletin Diagram: FIGURE 3 CAMSHAFT SPROCKET IDENTIFICATION

RIGHT CAM  
SPROCKET

LEFT CAM  
SPROCKET

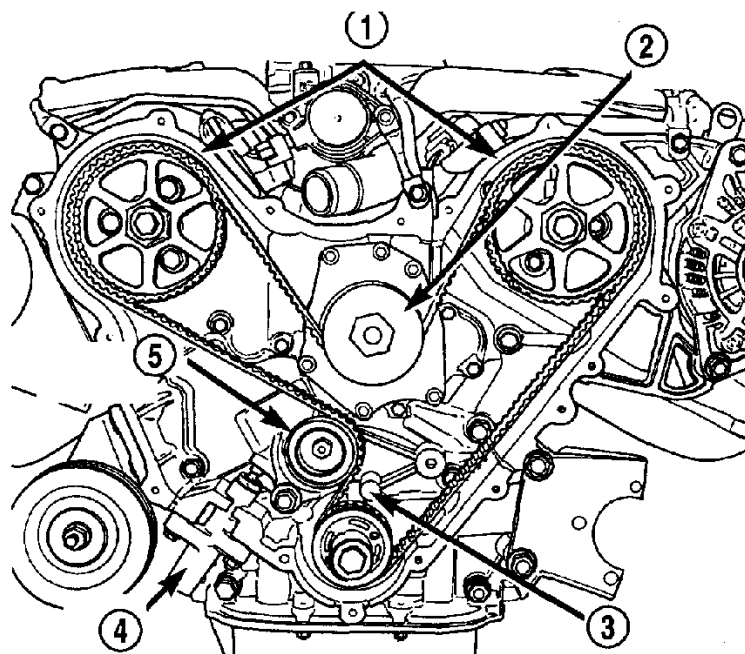
### Bulletin Diagram: FIGURE 4 TIMING BELT INSTALLATION

- 1 - REAR TIMING BELT COVERS
- 2 - WATER PUMP
- 3 - TDC INDICATOR
- 4 - BELT TENSIONER
- 5 - TENSIONER PULLEY

- 7) Starting at the crankshaft sprocket, install the timing belt in a counter clockwise direction (see Figure 3). Keep tension on the belt until it is past the tensioner pulley. Maintain tension by holding the pulley against the belt. Each camshaft mark should fall between the cover marks.
