| TECHNICAL BULLETIN | | Mfg: | CHRYSLER |
| | <b>June 2000</b><br><b>TB 1800</b> | Model: | NEON |

Timing Belt Tensioner Caution On  
1999-2000 Chrysler 1.8\* & 2.0L VIN C Engines

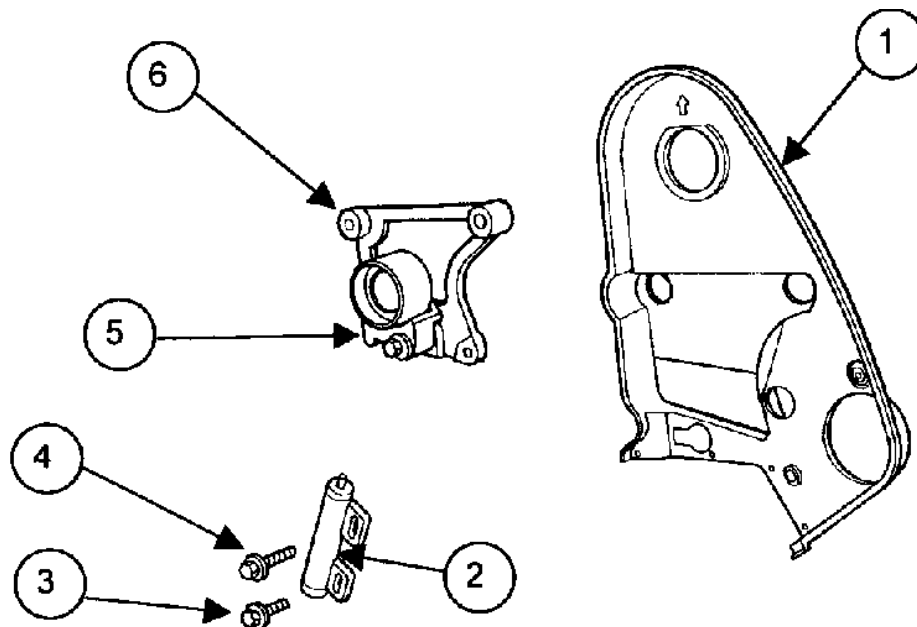
Bulletin Diagram: TB1800 Figure 1

As a result of parts consolidation by Chrysler, a kit is now available for repair done to the timing tensioner. Each kit consists of a tensioner with attaching bolts, tensioner pivot assembly and a rear timing belt cover as shown in Figure 1. Kit numbers and year applications are listed as follows:
