| TECHNICAL BULLETIN | |
| | <b>August 2000</b><br><b>TB 1815</b> |
| Model: | DURANGO |

Spark Knock & Oil Consumption On  
1994-99 Chrysler 5.2 & 5.9L VIN T, Y, C, Z & 5 Engines

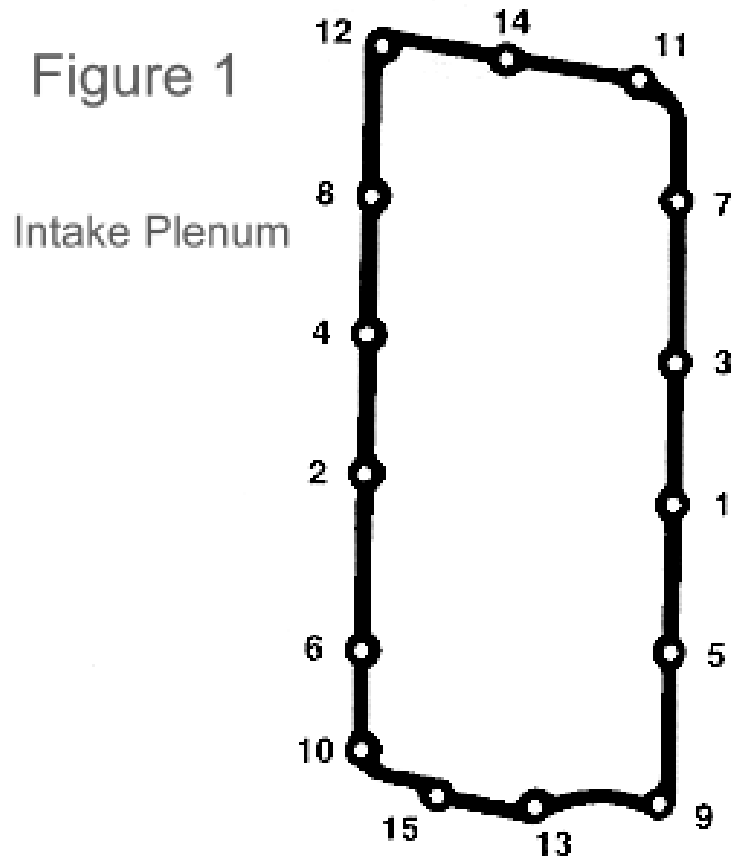
Bulletin Diagram: TB 1815 Figure 1

#### Plenum Pan Bolt Tightening Sequence & Torque Value (Figure 1)

- Step 1: Tighten all bolts in sequence to 48 in/lbs
- Step 2: Tighten all bolts in sequence to 84 in/lbs
- Step 3: Re-Check All bolts in sequence @ 84 in/lbs

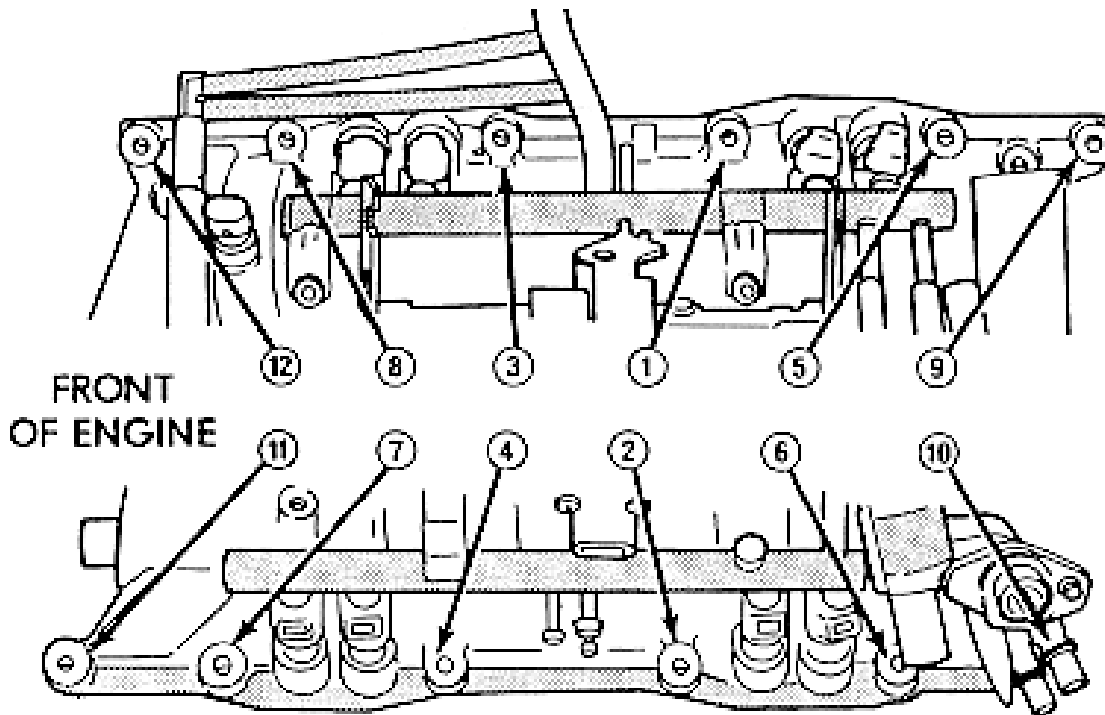
Bulletin Diagram: TB 1815 Figure 2

#### Intake Manifold Bolt Tightening Sequence & Torque Value (Figure 2)

- Step 1: Tighten bolts 1&2 in sequence to 12 in/lbs
- Step 2: Tighten bolts 1&2 in sequence to 24 in/lbs
- Step 3: Tighten bolts 1&2 in sequence to 36 in/lbs
- Step 4: Tighten bolts 1&2 in sequence to 48 in/lbs
- Step 5: Tighten bolts 1&2 in sequence to 60 in/lbs
- Step 6: Tighten bolts 1&2 in sequence to 72 in/lbs
- Step 7: Tighten bolts 3-12 in sequence to 72 in/lbs
- Step 8: Check all bolts in sequence @ 72 in/lbs
- Step 9: Tighten all bolts in sequence to 12 ft/lbs
- Step 10: Re-Check all bolts in sequence @ 12 ft/lbs
