| TECHNICAL BULLETIN | |

Cylinder Boring Caution For  
1986-99 Toyota 1.5, 2.0 & 2.2L 5E, 3S & 5S Engines

TB 1835R

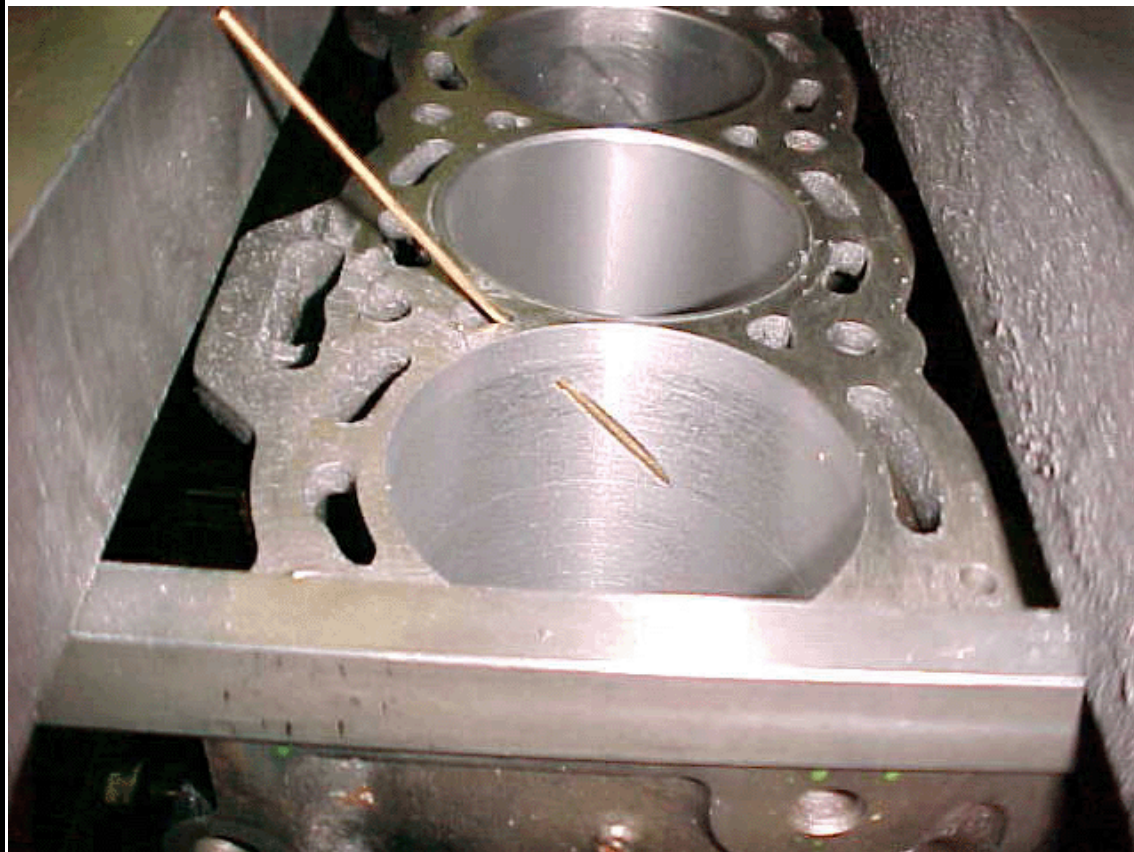
Bulletin Diagram: FIGURE 1, CYLINDER BLOCK HOLE - CYLINDER BLOCK

Apparently, depending on the amount of overbore the cylinder wall thickness may become insufficient to support compression. Reports of compression in the cooling system have resulted when the bore diameter has been increased by as little as .040" (1.000 mm) oversize.

These blocks have three angular coolant passages between the cylinders as shown below in Figure 1. The passages are drilled at approximately a 45° angle from the engine right side to the engine left side. These passages allow coolant flow between the cylinders and connect the right to left side water jackets.

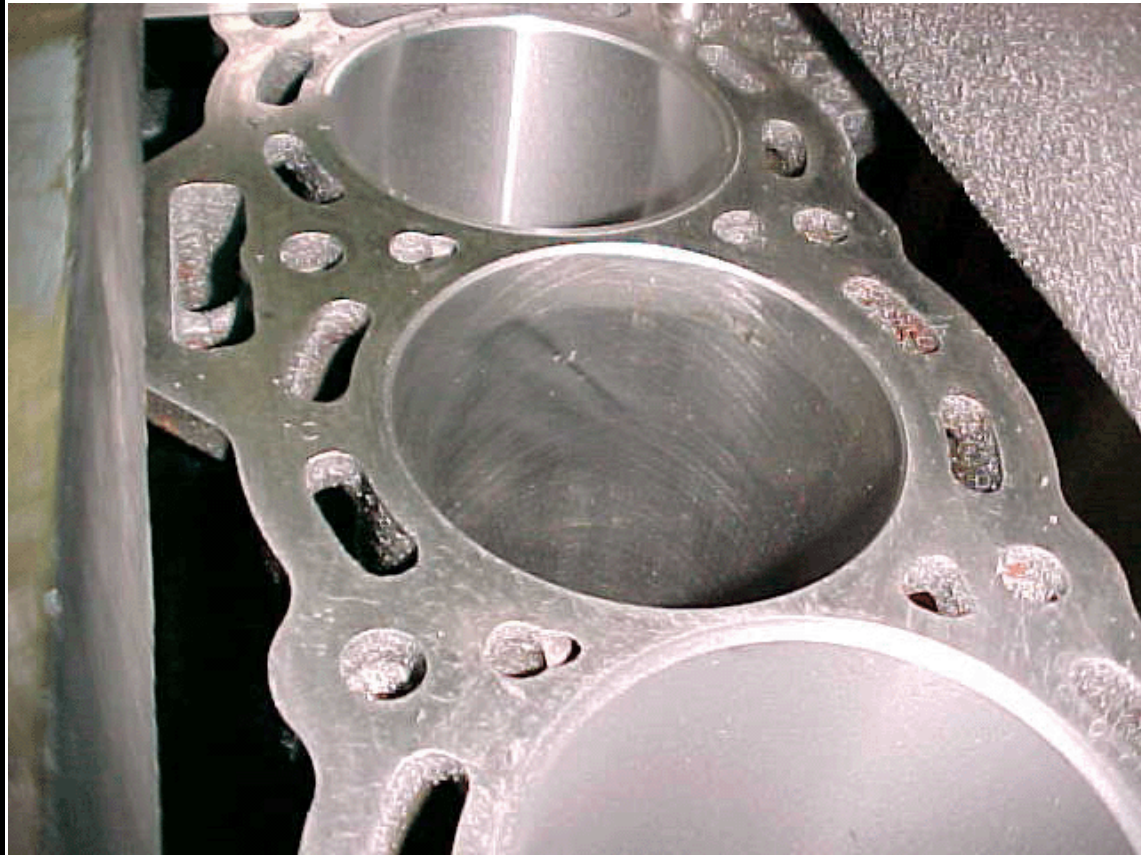
**Bulletin Diagram: FIGURE 2, DARK SHADOW OF COOLANT PASSAGE - CYLINDER BLOCK**

The shadow of the drilled passage can be seen in Figure 2 as a dark shadow on a failed block that had been bored and honed .040" and placed back in service. Combustion pressure within the cylinder after start-up created the through hole into the water jacket, resulting in combustion in the cooling system. Engine overheating will result when this condition exists. To repair this condition, AERA members report installing cylinder sleeves and then boring back to a standard bore diameter for all cylinders.
