| TECHNICAL BULLETIN | |
| | <b>December 2000</b><br><b>TB 1848</b> |

Camshaft Sensor Caution For  
2000 Chrysler 4.0L VIN S Engines

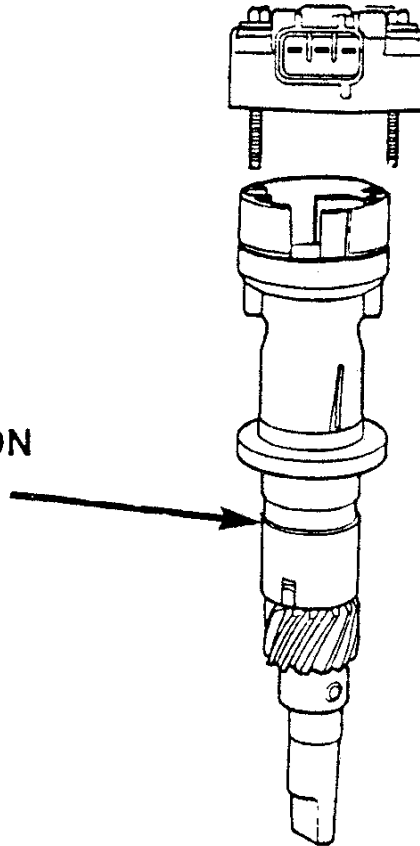
## Bulletin Diagram: FIGURE 1, LUBRICATION OILING HOLE - CYLINDER BLOCK

In some situations the camshaft sensor has seized and requires replacement. When replacing the camshaft sensor pay particular close attention that cam sensor/oil pump drive gear on the camshaft is not damaged. If there are signs of sensor damage or camshaft gear damage, be sure to pull the oil pan and check for debris. Replacement of the cylinder block is not generally necessary when this condition occurs.

If the camshaft sensor assembly is being replaced, remember to lubricate the shaft before installation. To perform this pre-lube, turn the assembly upside down and squirt clean engine oil into the lubrication hole. It is located just below the mounting flange on the side of the housing, see Figure 1. Also, rotate the shaft to insure the upper bearing surfaces are lubricated properly. Failure to pre-lube the shaft and upper bearing may result in a repeat no-start condition.
