| TECHNICAL BULLETIN | |
| | <b>December 2000</b><br><b>TB 1849</b> |
| Mfg: | FORD |

Sudden Loss of Oil Pressure On  
1996-97 Ford 7.3L VIN F Engines

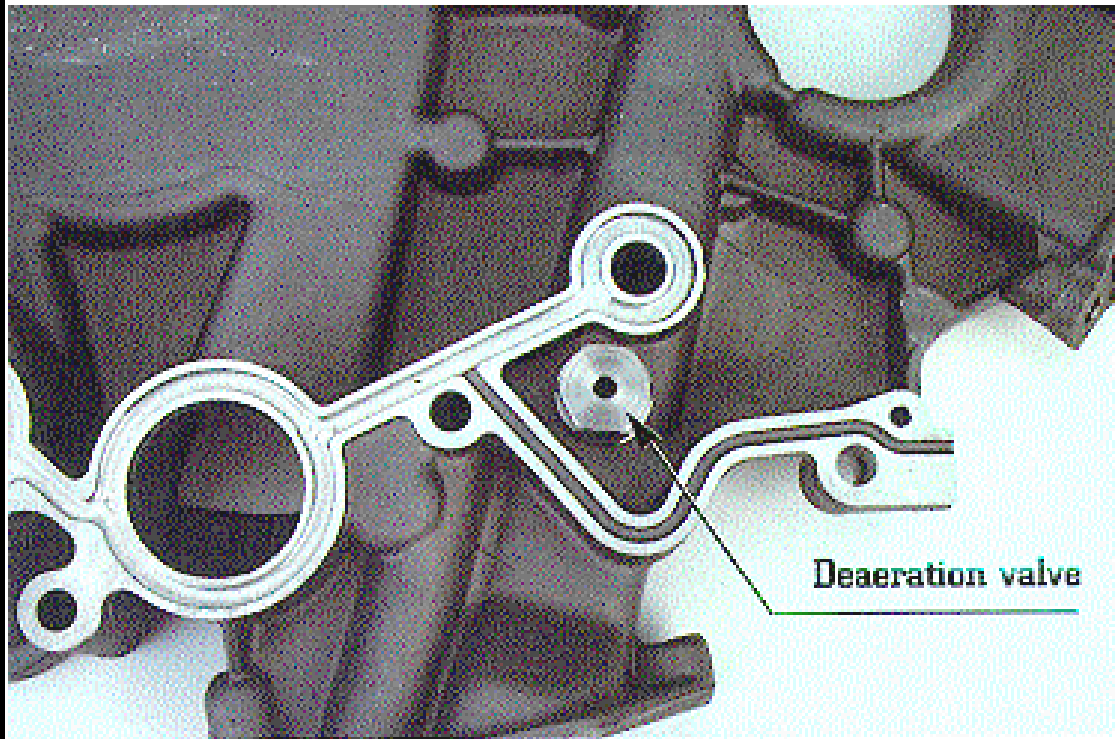
Bulletin Diagram: FIGURE 1, DEAERATION VALVE - CYLINDER BLOCK

The cause of this engine oil pressure loss is resulting from the oil systems threaded de-aeration valve re-locating within its threaded opening. Depending on the movement and location of this valve, varying amounts of pressure loss have been reported. If the valve is completely dislodged, a  $\frac{3}{4}$ " opening will exist in the pressure side of the oiling system. The valve may have loosened from extended engine cycles and normal engine vibrations. It is suggested to use Loctite® on the threads of this valve when re-installing. The valve is located within the front cover of the engine as shown below in Figure 1.

Engines built beginning with serial #201681 through 375549 used this de-aeration valve. Engines built beginning with serial #375550 were redesigned and did not incorporate the de-aeration valve.

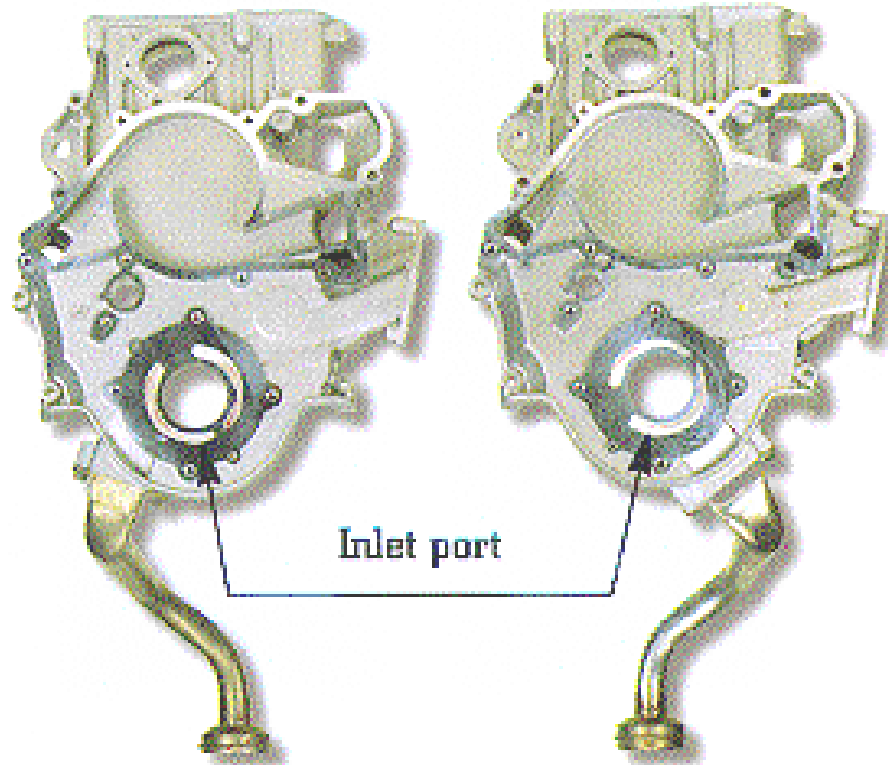
### Bulletin Diagram: FIGURE 2, INLET PORT RELOCATION - CYLINDER BLOCK

The front cover was also redesigned with serial #375550 to help keep the oil pump primed for initial start up. To accommodate this change, the oil pump inlet port was rotated approximately 90° which also moved the pick up tube from the engine's left side to the engine's right side as shown below in Figure 2.
