| TECHNICAL BULLETIN | |
| | <b>January 2001</b><br><b>TB 1858</b> |

Low Engine Performance On  
2000 Chrysler 4.7L VIN N Engines

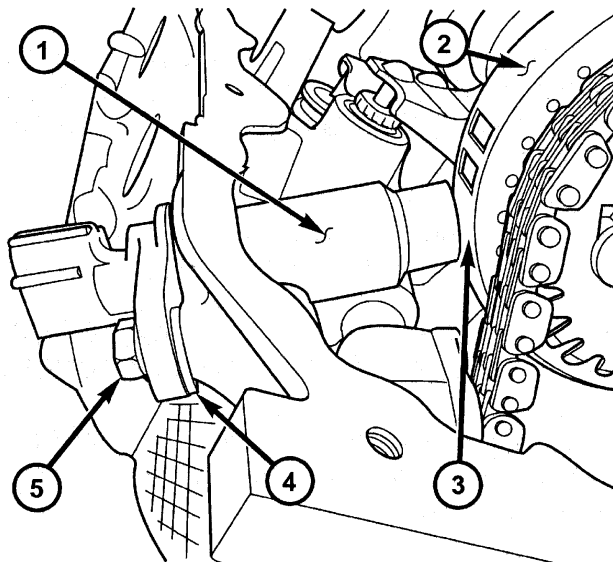
FIGURE 1

The loss of the CMP signal may be the result of the CMP coming in contact with the tone wheel. If this occurs, the internal electronic circuitry of the CMP may become damaged. When this happens, there is a chance that the Malfunction Indicator Lamp (MIL) may become illuminated.

The shim may also have been glued in place to either the cylinder head or the mounting tang on the camshaft position sensor. If a technician is making repairs, they may overlook or lose the previously installed shim. This may cause the camshaft position sensor to contact the tone wheel when the CMP sensor is reinstalled or replaced.

Most of these engines were inspected and repaired at the manufacturing facility. Some engines may need to be repaired. If the engine is in need of repair, there is a select fit shim that needs to be installed between the CMP and the cylinder head pad, around the CMP sensor attaching bolt as shown in Figure 1. The shims come in four different thickness depending on the amount of air gap that needs to be shimmed. The four sizes are .010", .020", .031" and .047".
