| TECHNICAL BULLETIN | | |
| | <b>March 2001</b><br><b>TB 1870</b> | <b>Mfg:</b> GM |

Coolant Leakage On  
1995-2000 GM 3800 VIN K Engines

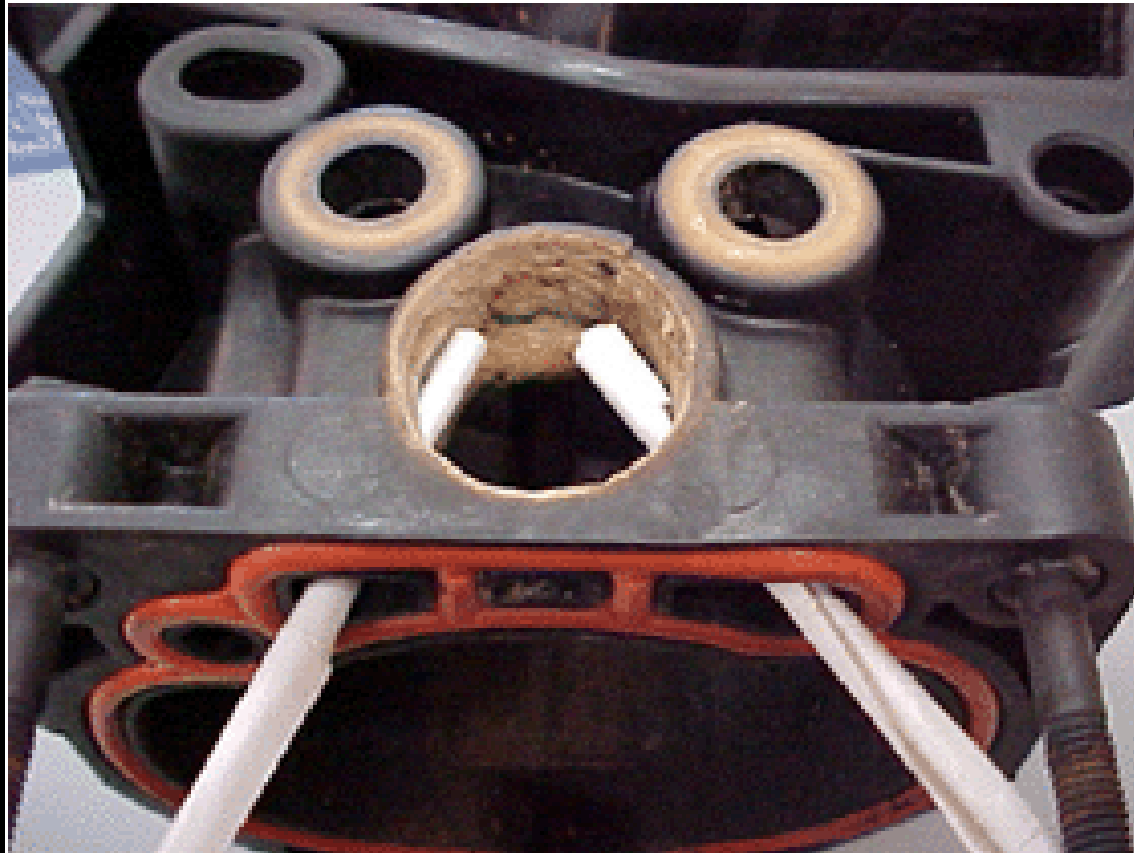
### Bulletin Diagram: FIGURE 1, EXHAUST GAS TRANSFER HOLES - MANIFOLD

The coolant leaks in these situations have been reported leaking from the upper plastic intake plenum. This plenum cracks or erodes in the coolant transfer hole that is supplied coolant from the lower intake manifold as shown in Figure 1. Two straws are inserted in this passage to illustrate where the coolant transfer ports are. Those passages actually provide a route for coolant to go into the throttle body area.

This particular failure usually starts by an unexplained small amount of coolant loss. Customers complain that they always have to top off the coolant. Until, the leakage increases to an amount that will finally provide an air, fuel and coolant mixture that will not support combustion. When that occurs, the engine goes into a no start situation and the plastic plenum must be replaced.
