| TECHNICAL BULLETIN | |
| | <b>TB 1950</b> |
| <b>Mfg:</b> | <b>GM</b> |

Intake Manifold Removal & Installation Caution For  
1995-2001 GM 3.8L VIN K Engines

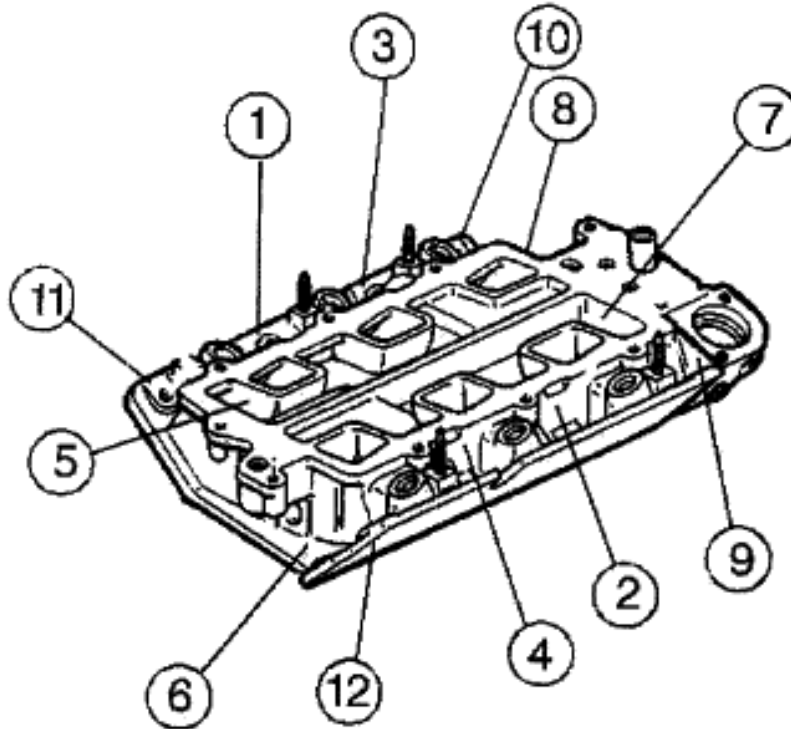
### Bulletin Diagram: FIGURE 1, LOWER MANIFOLD TORQUE SEQUENCE - MANIFOLD

Those two bolts are located in the right front and left rear corners of the lower intake manifold and illustrated below in Figure 1 with numbers 5 and 7. Attempting to remove the two manifolds as an assembly will fracture the mounting location of lower unit.

The caution expressed for installing the lower intake manifold is to make sure and use a locking compound on the bolt threads and to adhere to the minimal torque value used.

1. Clean the cylinder block, heads and the intake manifold sealing surface of all oil with a suitable solvent.
2. Clean the intake manifold bolts and bolt holes of adhesive compound.
3. Apply GM P/N 12345493 approved thread locking compound to the intake manifold bolt threads before assembly.
4. Tighten the mounting bolts in sequence to 11 ft/lbs (15 Nm).

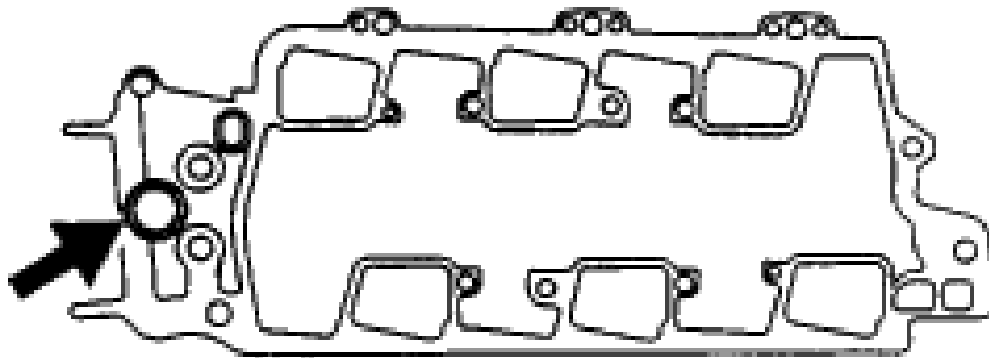
### Bulletin Diagram: FIGURE 3, POSSIBLE DEGRADING OF COMPOSITE MATERIAL - MANIFOLD

NOTE: Lower Intake manifolds used from 1995-98 originally used lower intake manifold Part # 24505728. That manifold should be replaced with the improved manifold Part #24508923 when degrading is observed in the composite material around the EGR stove pipe as shown by the arrow in Figure 3. Replacement of the upper intake with Part #17113136 is also necessary when the improved manifold is used
