| TECHNICAL BULLETIN | |
| | <b>April 2003</b><br><b>TB 2062</b> |
| <b>Mfg:</b> GM<br><b>Model:</b> SUBURBAN<br><b>Liter:</b> 7.4L<br><b>V I N:</b> J<br><b>Year:</b> 96-00 | |

Cracked Distributor Magnets For  
1987-2002 GM Electronic Ignition Engines

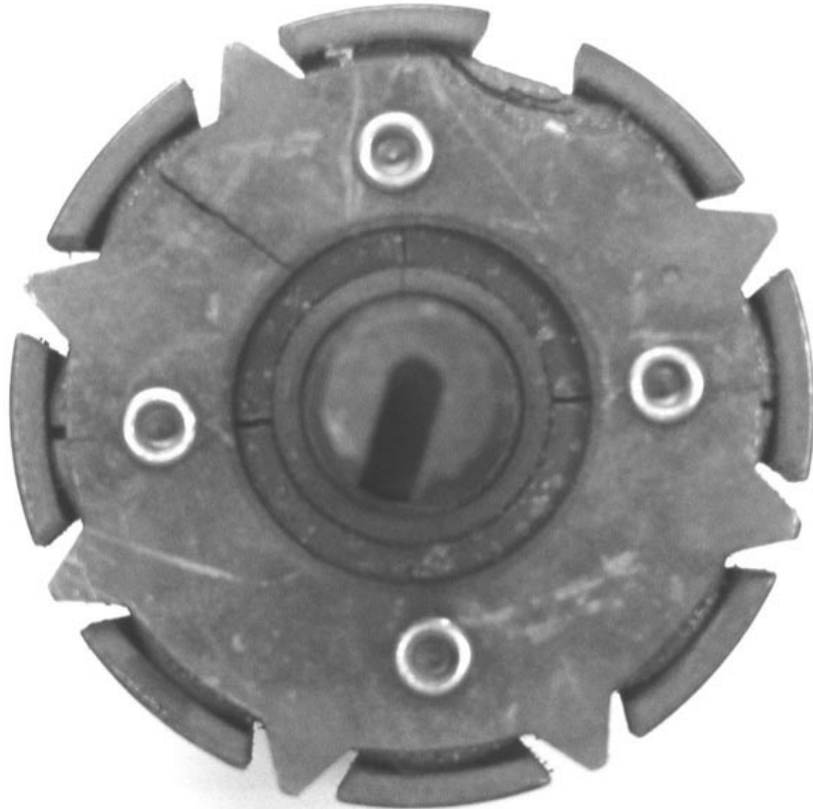
The installation of a distributor with a crack(s) in this area, will lead to uncertain ignition impulses. If left installed and continued engine operation occurs, eventual engine damage is likely. This presence of these cracks may also have contributed to original engine failure.

It has been observed that cracked magnets in a distributor may lead to drivability problems and even detonation. In many instances, it has also been the cause the of original engine failure. Please note the cracks in the photo below are extreme. Most cracks are not this noticeable to the naked eye. Those unnoticeable cracks, however, do present the need to replace the distributor, as spark scatter will result during an undetermined engine load.

### Bulletin Diagram: MULTIPLE CRACKS IN MAGNET - FAILURE ANALYSIS
