| TECHNICAL BULLETIN | | Mfg: | GM |
| | June 2004 | Model: | TRAILBLAZER |
| | TB 2169 | V I N: | S |

Revised Piston Assembly For  
2002-03 GM 4.2L VIN S Engines

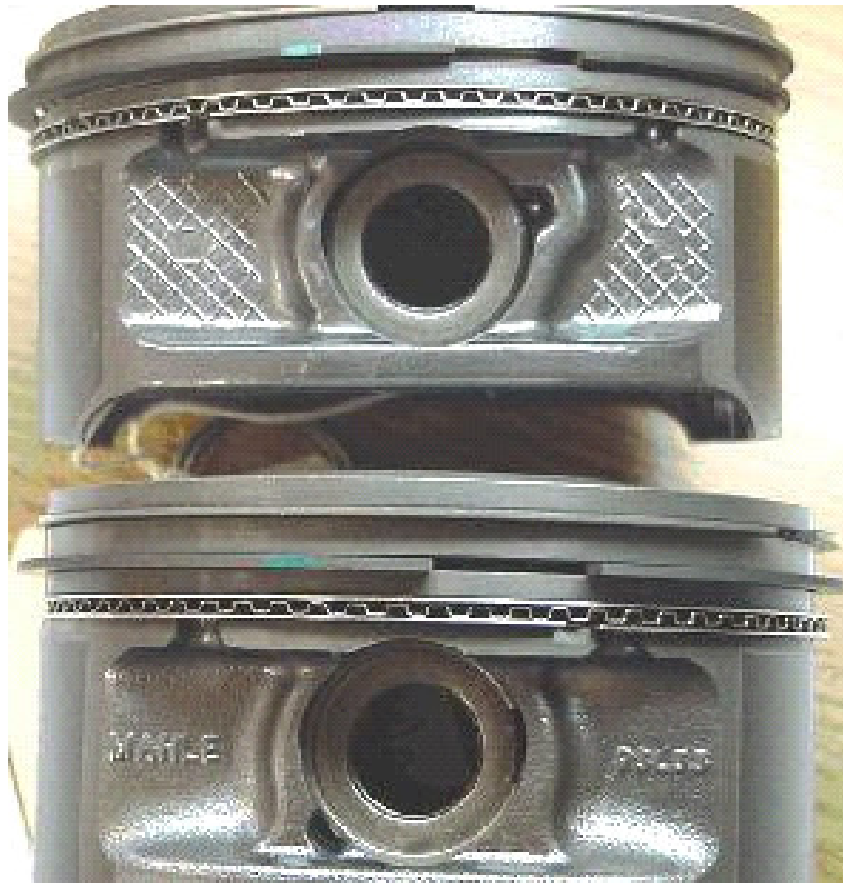
**Bulletin Diagram: FIGURE 1. REVISED PISTON ASSEMBLY, AT TOP - CYLINDER BLOCK**

The new piston, Part #88984235 (includes pin & rings) is different in appearance and characteristics from the previous design. There is also a .25mm Over Size Piston available with rings under Part #88984236. The revisions are significant enough to require all pistons to be changed when any single piston replacement is anticipated on engines built before EUN V301290522. The EUN may be found on the left side of the engine under the air conditioner compressor bracket or at the rear of the back of the cam cover.

If the EUN number is unobtainable or illegible, it is imperative that all six pistons be replaced as intermixing the different designs will result in excessive engine vibration. Piston rings for the first design piston will not be available from GMSPO.
