| TECHNICAL BULLETIN | |
| | <b>October 2004</b><br><b>TB 2205</b> |

Second Design Connecting Rod Bolt & Torque Specification  
1997-1999 GM 4.8, 5.3, 5.7, 6.0L VIN G, U, T & V Engines

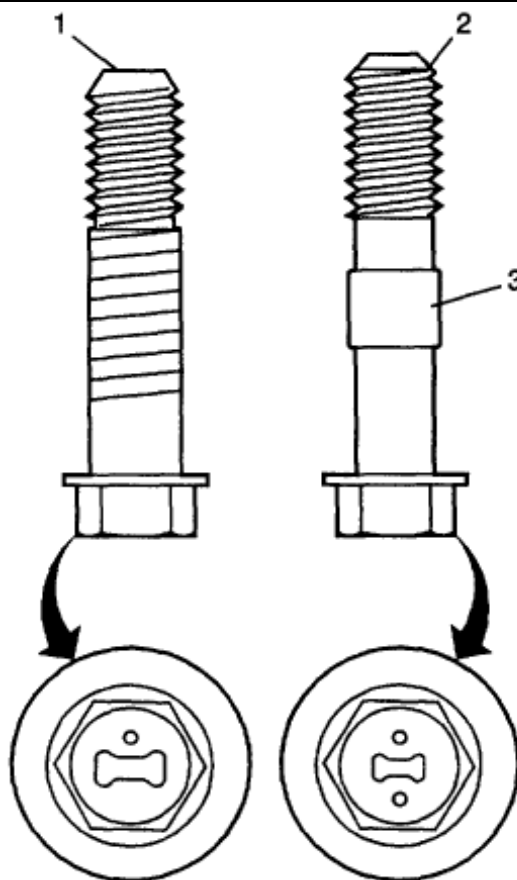
## Bulletin Diagram: FIGURE 1. REVISED CONNECTING ROD BOLT - CYLINDER BLOCK

The first design connecting rod bolt (1) can be identified by a single dimple/mark on the head of the bolt and no retaining sleeve (3) on the bolt shank.

The second design connecting rod bolt (2) can be identified by two dimples/ marks on the head of the bolt and a retaining sleeve (3) on the bolt shank.

Important: When replacing the connecting rod bolts, both bolts MUST be of the same design for each connecting rod assembly. The use of different design connecting rod bolts on the same connecting rod may lead to uneven clamp loads and/ or connecting rod bearing bore distortion.

Tighten the first design bolt: 1ST pass to 15 FT/LBS, final pass turn + 60°.

Tighten the second design bolt: 1ST pass to 15 FT/LBS, final pass turn + 85°.
