| TECHNICAL BULLETIN | |
| | <b>November 2004</b><br><b>TB 2212</b> |

Rear Main Seal Leakage, Preventative Measure For  
1997-2005 Chrysler 4.0L VIN S Engines

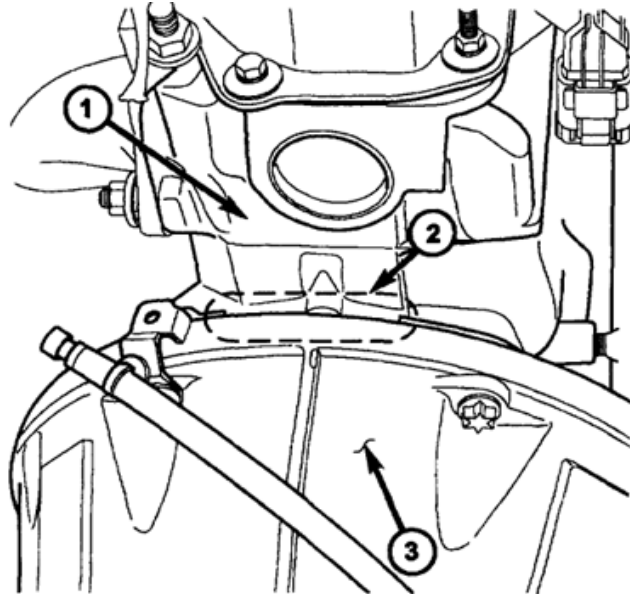
**Fig. 1 LOCATION OF ADAPTER OPENING**

There have been occasional reports of rear main seal leakage on certain vehicles using the above combination. Closer inspection of suspect vehicles may reveal the cause of the engine oil seepage past the rear main seal is due to the accumulation of dirt and debris around the outside of the rear main seal. This accumulation may act as an abrasive while rotating on the crankshaft and damage the seal and surface.

A spacer plate is used to mate the transmission bellhousing to the back of the engine. The spacer plate has a slot machined into it at the 12 o'clock position. A small opening may occur as a result of the spacer slot when the spacer is mated between the engine and transmission bellhousing. The narrow spacer opening at the top may allow small size debris to accumulate around the outside of the rear main crankshaft seal. Vehicles used in dusty off road situations have been more severely affected.

- 1 - BACK OF ENGINE
- 2 - LOCATION OF NARROW OPENING DUE TO SLOT IN ADAPTER PLATE
- 3 - TOP OF BELLHOUSING - MANUAL TRANSMISSION

To prevent this type of condition, seal the area at the time of engine installation on remanufactured engines. Chrysler/Jeep has suggested this type of repair after the rear seal and or crankshaft has been repaired by applying a liberal bead of RTV sealer to the area. Make sure to thoroughly clean the area before applying the sealer to area 2 in the Figure 1 below.
