| TECHNICAL BULLETIN | |
| | <b>July 2002</b><br><b>TB 1994</b> |

Excessive Oil Consumption For  
1993-97 Ford 2.0L VIN 3 Engines

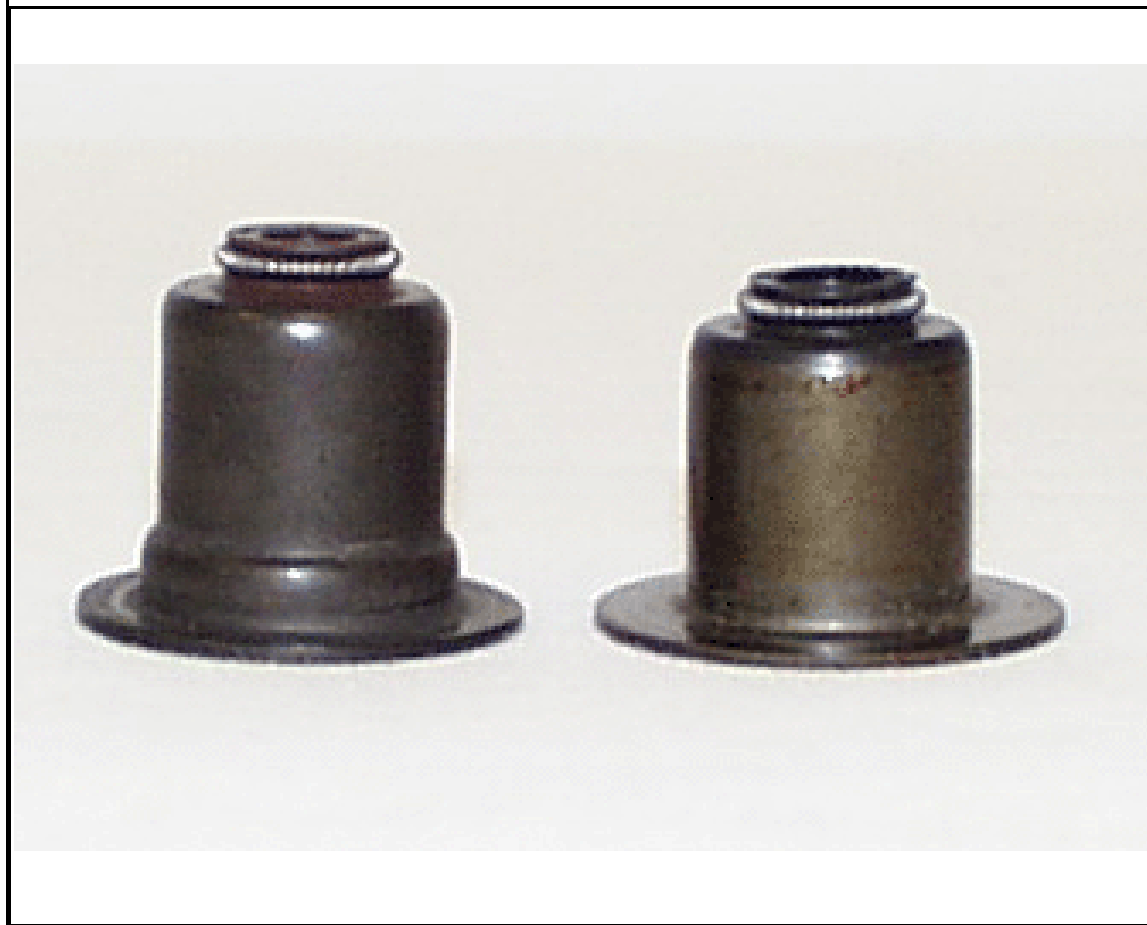
**Bulletin Diagram: FIGURE 1, After 3/13/1996 taller "A", Before "B" - CYLINDER HEAD**

The Figure below shows the taller seal used after 3/13/1996 on the left, and the shorter seal before 3/14/1996 on the right.

| | After 3/13/1996 taller, "A" | before 3/13/1996 shorter, "B" |
| Guide side OD | .460" | .480" |
| Spring seat | .945" | 1.000" |
| Over-all height | .820" | .745" |
| Valve stem ID | .190" | .200" |

The correct valve stem seal must be used, because of the seals' press fit over the valve guide. Tool #T90P-6510-AH, when used, correctly positions the seal over the valve guide. This press fit is mandatory so no oil can pass between the seal and valve guide.

It is possible to install the earlier, larger ID seal on the later valve guides, which results in excessive oil consumption. If the larger diameter seals are installed on the later production heads and guides engine oil may pass between the seal and valve guide.
