## TECHNICAL BULLETIN

Mfg : VOLKSWAGEN  
Model: PASSAT  
Liter : 1.8  
VIN : AEB  
Year : 1998-01

### TB # 2200 CRACKED VALVE SPRING RETAINER FOR 1.8L AUDI/VOLKSWAGEN TURBO

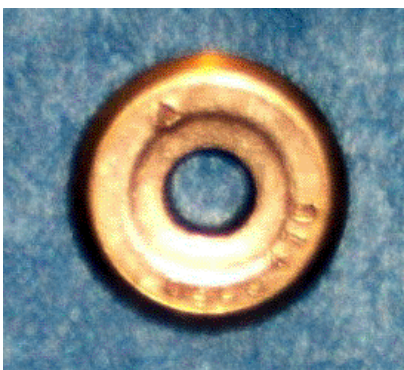
FIGURE 1. REVISED VALVE  
RETAINER

It had been reported exhaust valve retainers have cracked while in service and allowed valve keys to unlock a valve while the engine is running. This, of course, causes catastrophic engine damage. It appears this condition may be the result of a product failure as revised retainers are currently available from Audi/Volkswagen. To date, it has only been exhaust locations that have been affected.

Fortunately (at that time), parts identification from previous and revised retainer was possible through visual inspection. Previously manufactured parts had a portion of the Part Number 058641B embossed on top of the exhaust retainer as shown in Figure 1 below. Currently (at that time), manufactured components did NOT have any numbering on top of the retainer and are available with Part #058109641B.

Some AERA member shops report that 100% replacement of exhaust retainers that have numbering embossed on the top is good practice anytime the cylinder head is removed. Some shops also report making visual inspections of possibly affected engines anytime the vehicle is in for service work.
