## Oil Restrictor Caution on 2008-2011 GM 1.6, 1.8L Engines

The AERA Technical Committee offers the following information on an oil restrictor caution for 2008-2011 GM 1.6 & 1.8L LXV & 2H0 engines. These engines are used in Chevrolet Aveo, Pontiac Wave & G3 and Saturn Astra vehicles.

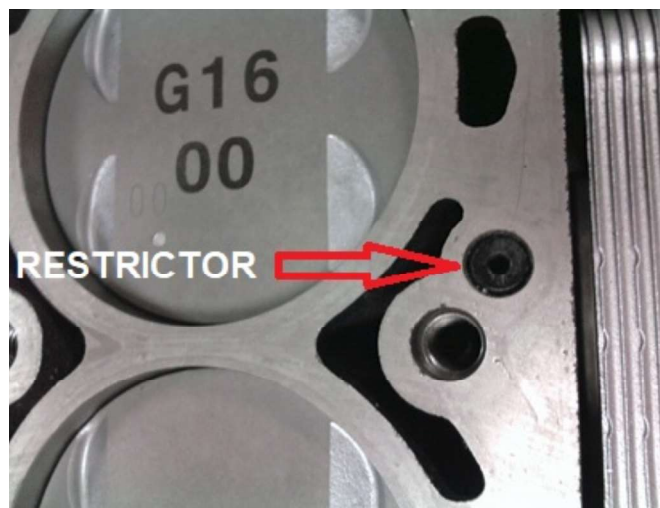
**Figure 1. Oil Restrictor in Block Deck**

When the cylinder head has been removed, it is important to visually inspect the restrictor shown in Figure 1 below. The restrictor orifice is located on the exhaust side of the block, between cylinders' number 2 and 3. There have been reports of melted or distorted restrictors on engines that have been severely overheated. If this condition is observed by finding a distorted or melted piece of plastic, further engine diagnosis may be required. Apparently, the high temperature plastic oil feed restrictor orifice in the block deck has exceeded its designed temperatures.

If it becomes necessary to replace the restrictor orifice, not related to excessive engine temperature damage, please use the latest part number listed in the GM parts catalog.
