| TECHNICAL BULLETIN | |
| | <b>TB 2167</b> |

Engine Damage On  
1998-2004 Chrysler 2.7L VIN R, U & V Engines

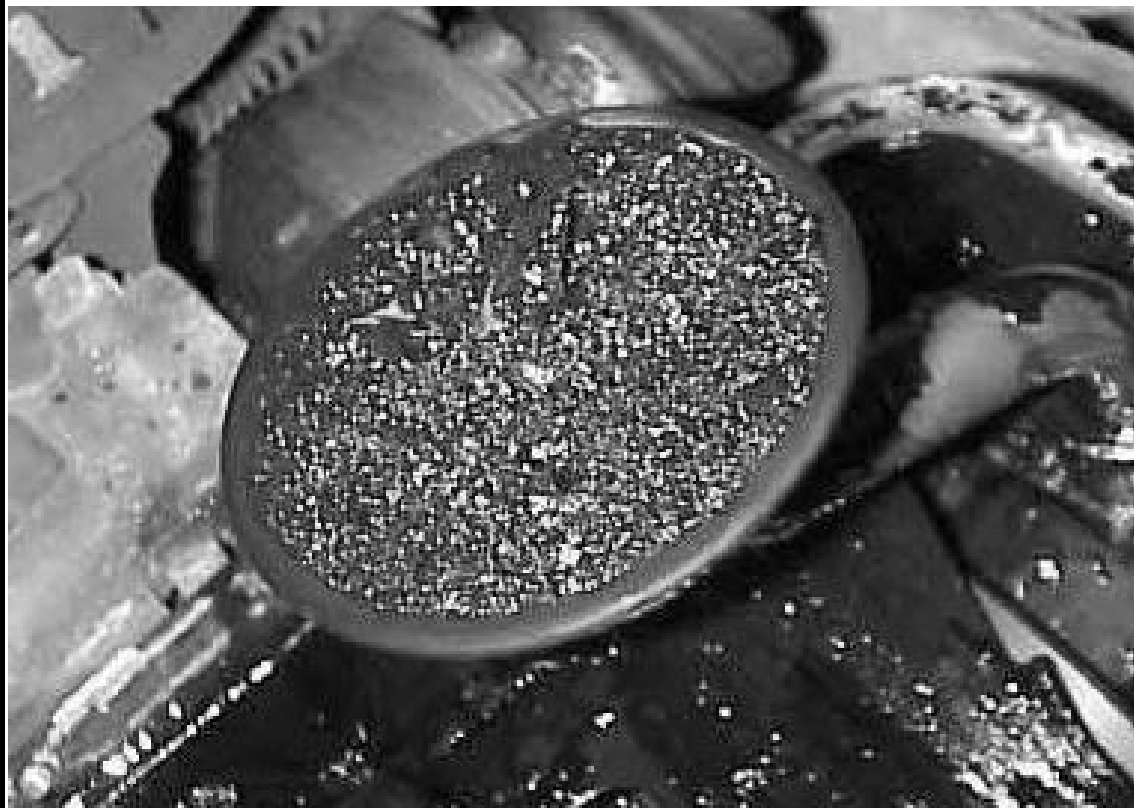
### Bulletin Diagram: FIGURE 1. - CYLINDER BLOCK

It has been suggested that many of these failures may be the result of engine oil sludge or gelling. This condition exists when the engines oil is no longer able to disperse harmful contaminates, thus reducing lubrication of the needed parts. One cause of engine failure is oil sludge accumulating in the cylinder head drain back passages preventing sufficient oil flow from the top of the engine to the oil pan. Another is a similar situation of sludge build up on the oil pump pickup screen as shown in Figure 1 below.

Some AERA members report repeated engine oil flushes and oil changes may be a temporary resolve for effected engines that have not suffered major failure. Also, much shorter oil change intervals are necessary, perhaps as often as every 1000 miles to keep the sludge from reappearing.
